## JACKSONVILLE ELECTRIC AUTHORITY PLAZA III PARKING GARAGE RESTORATION PROJECT

Recognized for **Excellence** in the **Repair of Parking Structures** – December 7, 2012  
**International Concrete Repair Institute** – Great Plains Chapter

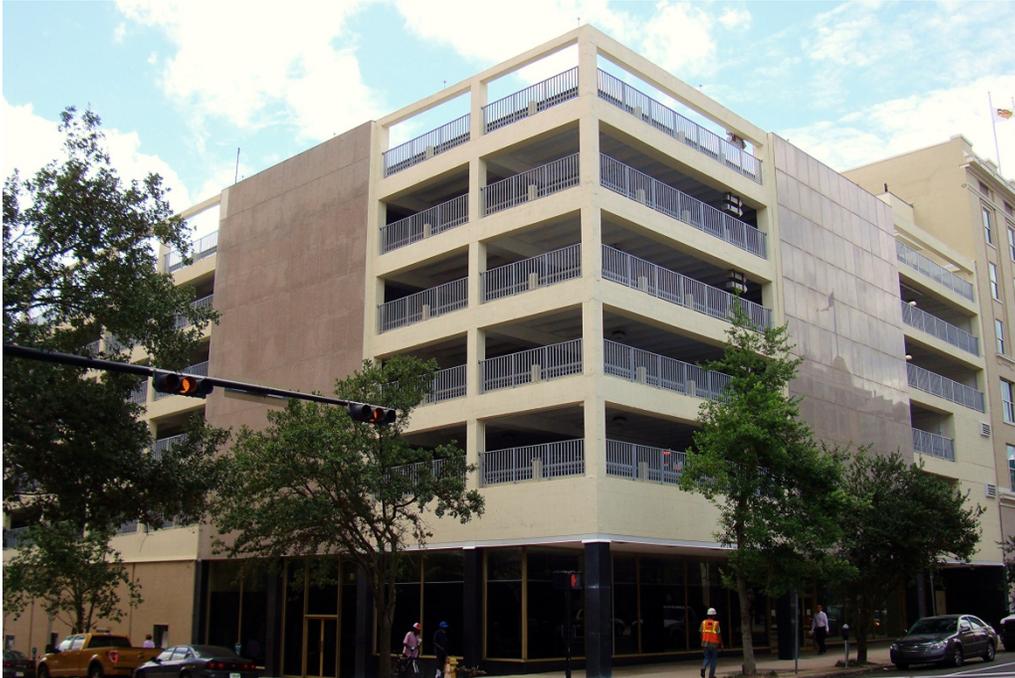
The JEA Plaza III parking garage is a seven-story reinforced concrete framed structure. Existing plans were available at the time of the project to determine the date of construction, which indicated that the garage was constructed around 1963. The area of structural concern was the deterioration of the concrete elements including the beams, columns and pan joist floor system. In addition to the deterioration of the primary framing, the concrete curtain wall system was crumbling and was a safety concern to the general public. Construction consisted of reinforced cast in place concrete members. The project was separated into several phases which began with initial condition survey services in 2006 and construction completed in 2012.

High-strength polymer modified repair mortars that contain corrosion inhibiting admixtures as well as epoxy bonding agents were used to replace sections of deteriorated concrete. The exterior façade was replaced with a new railing system that met current code requirements.
