OCEAN 14 CONDOMINIUMS CONCRETE RESTORATION PROJECT

Recognized for **Excellence** in the **Repair of High-rise Structures** – December 3, 2009
International Concrete Repair Institute – Great Plains Chapter

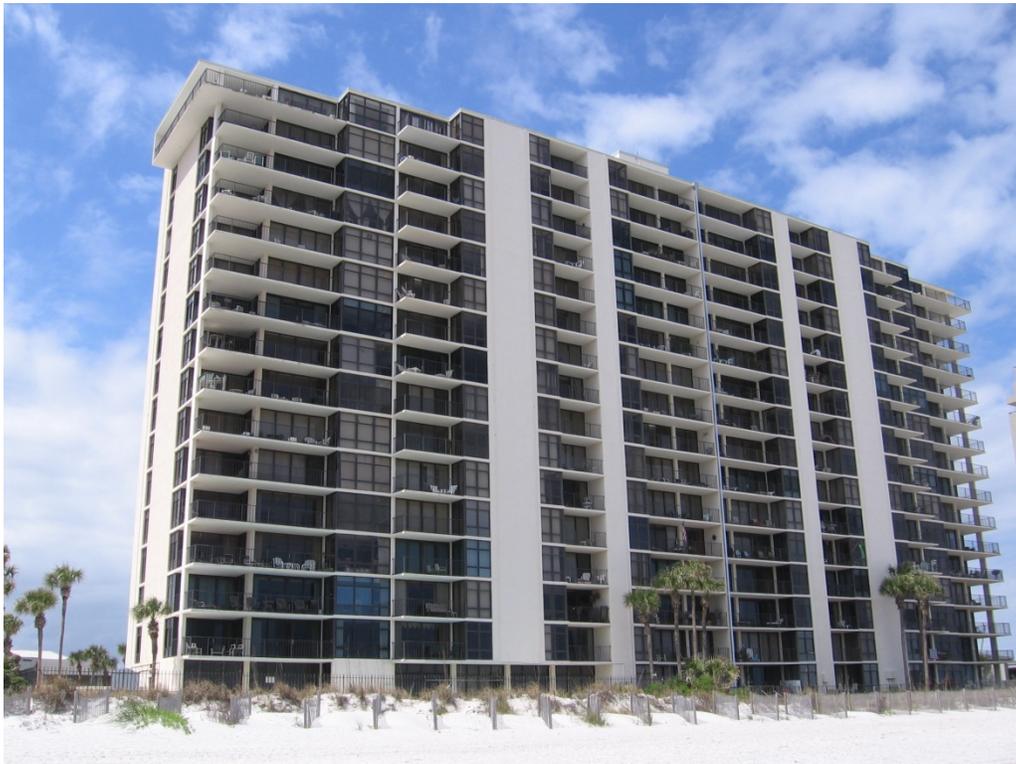
The Owners were concerned about spalling concrete and exposed reinforcing steel on many of their balconies, beams and columns. In addition, they were interested in having the building coated to mitigate water intrusion.

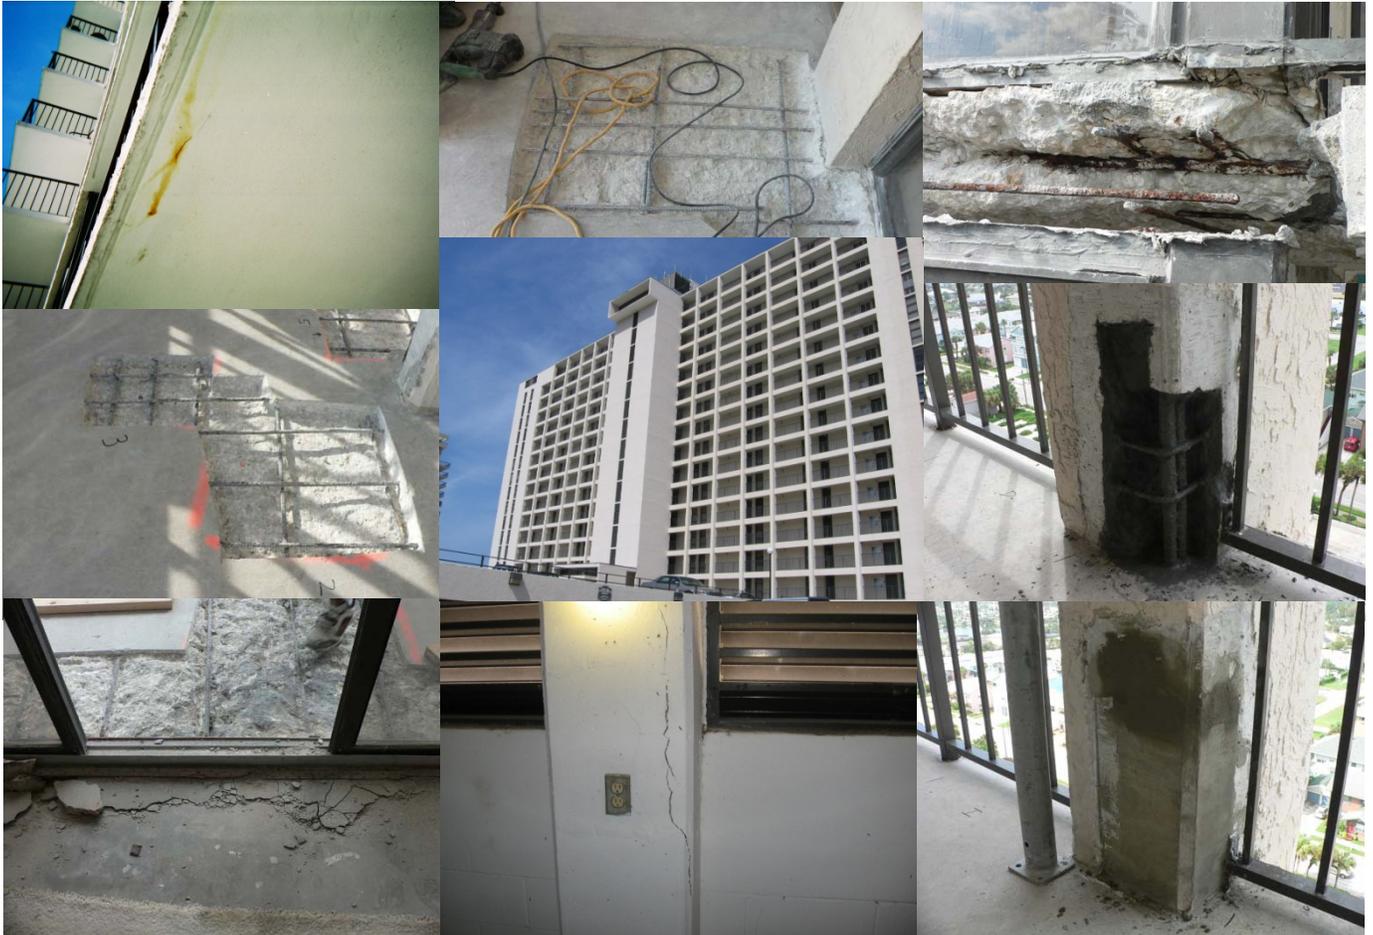
On-site structural investigations were performed to the entire structure to develop a set of repair drawings that would indicate the locations of and types of repairs to be completed. Structural deficiencies were identified during the condition survey thru destructive testing methods by manually removing loose delaminated concrete. Non-destructive testing included visual observations and soundings. No concrete strength, chloride content or ph level testing was performed since entire concrete elements were identified to be removed and replaced.

High-strength polymer modified repair mortars that contain corrosion inhibiting admixtures as well as epoxy bonding agents were used to replace sections of deteriorated concrete.

Most repairs were performed with form and pour procedures while a few locations were performed with hand-applied methods. Swing stages were utilized in vertical stacks to access the exterior of the building structure.

Edges of concrete to be repaired were scored a minimum of ½" with square edges and care was taken to not cut any existing reinforcing steel to remain in place. Existing exposed reinforcing steel was cleaned with mechanical wire wheels and grinders. Epoxy bonding agents were used to coat existing reinforcing steel as well as any concrete surfaces that would bond with new repair mortar.
